**Monthly Progress Report #3  
September 14, 2009**

**U.S. EPA Region 5 / VIM Recycling, Inc.  
Administrative Consent Order # EPA-5-09-113(a)-IN-05**

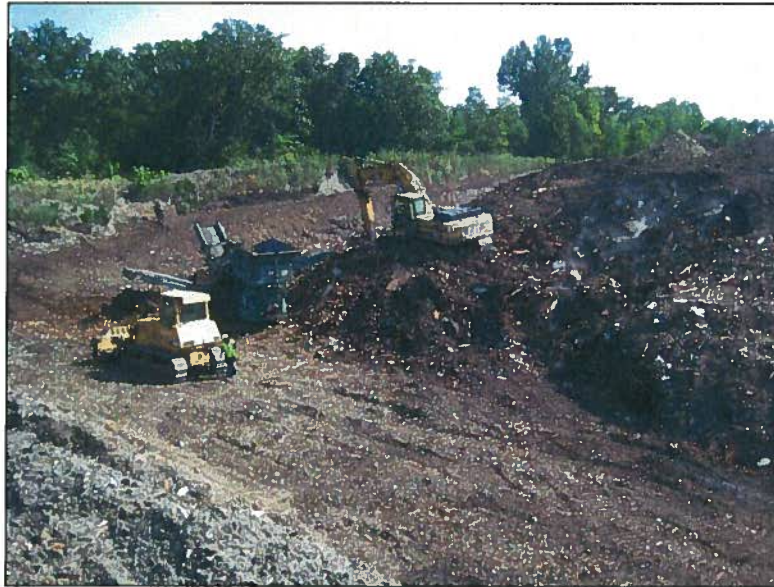
**Photo 1.** VIM Recycling, Inc., Elkhart operations

**Description:** Excavation, sorting, screening operations on northwest corner of C-1 pile

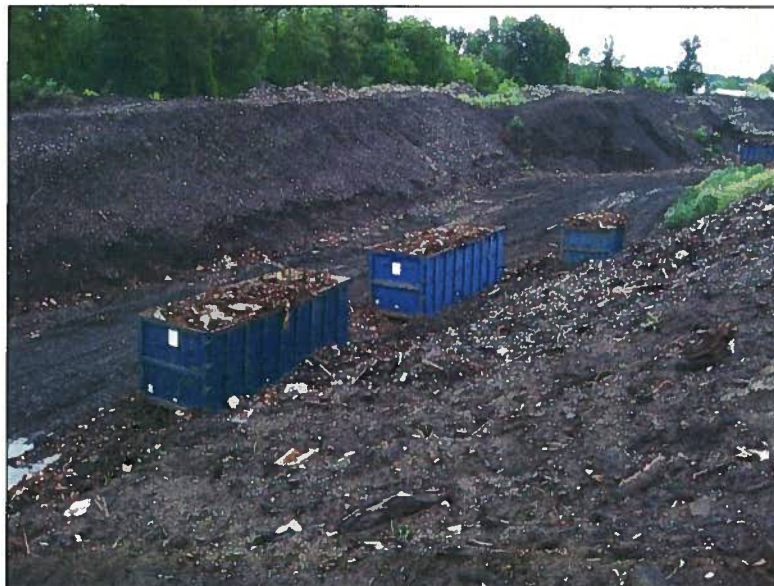
**Photo 2.** VIM Recycling, Elkhart operations

**Description:** 50 yd roll-off containers filled with overs staged for removal to landfill

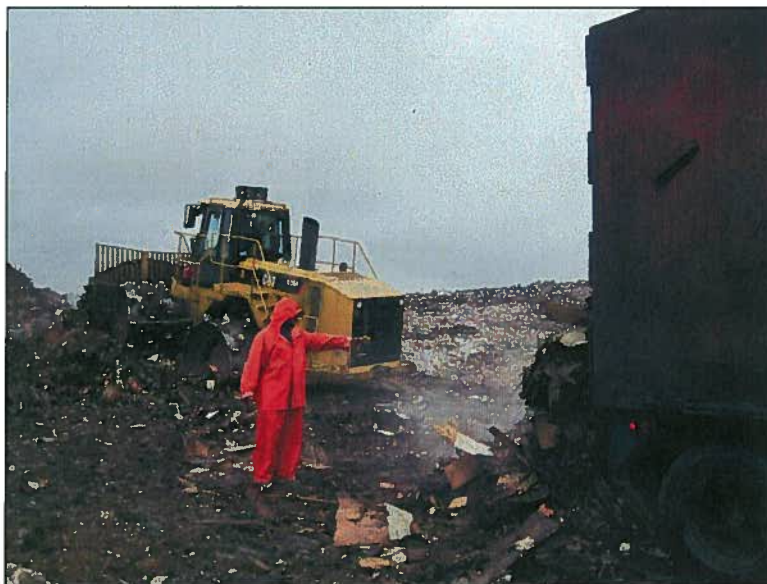
**Photo 3.** Elkhart County Landfill, Elkhart

**Description:** Landfill personnel monitoring temperature of incoming load of overs

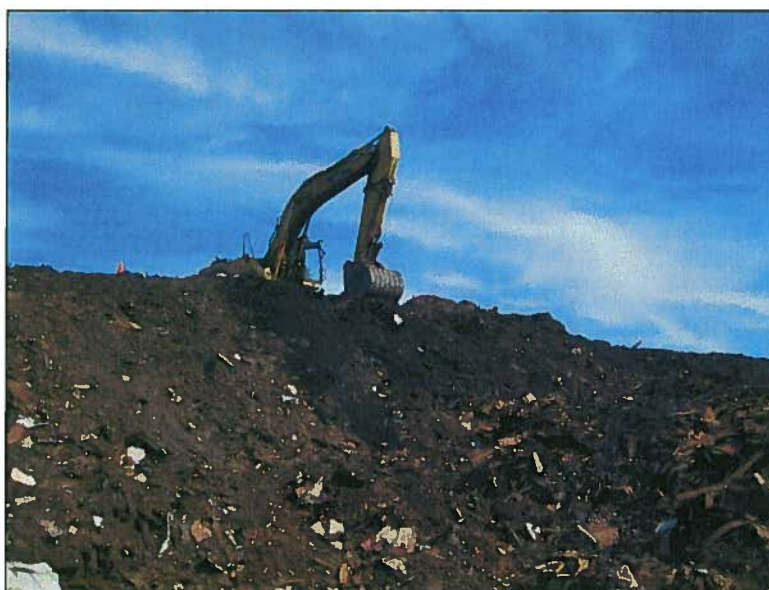
**Photo 4.** VIM Recycling, Elkhart operations

**Description:** Cat 330 excavator covering daily excavation face with topsoil to control smoke & steam

- Several instances of excessive smoke and steam releases took place during the reporting period. These events are caused by hot or smoldering woody wastes that appear near the surface of the C-1 stockpile. In all cases, these events were detected by VIM surveillance personnel or reported to the Baugo Fire Department. These situations are typically addressed by the excavation of the hot material and the application and subsequent compaction of soil onto the impacted area.

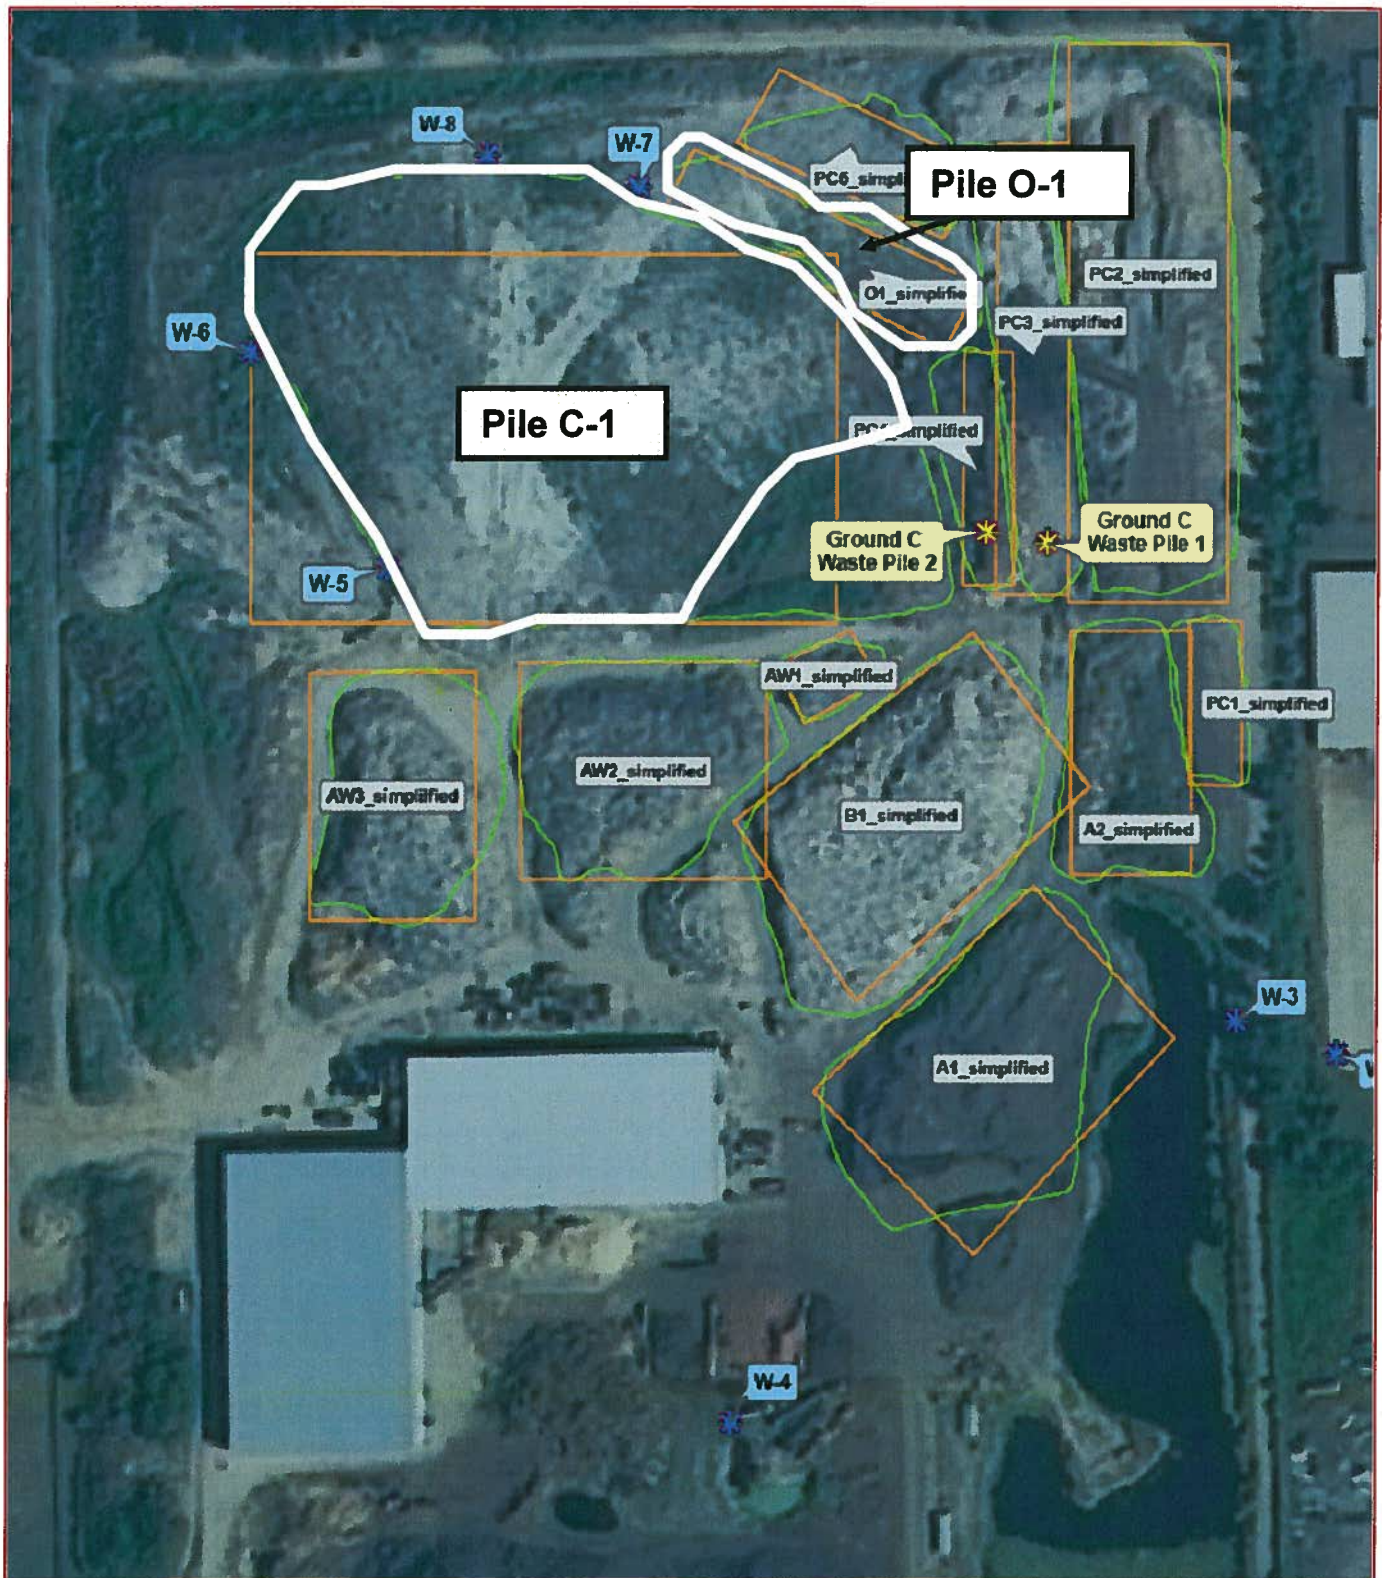
**Attachment 1. Boundaries of “C Pile” material stockpiles to be addressed pursuant to paragraph 31 of Compliance Program\***

- The topographic survey (see Attachment 2) shows the original footprint of the C-1 pile along with the August 3<sup>rd</sup> and September 1<sup>st</sup> updated contours to highlight the progress made in removing the C-1 pile during the reporting period.

**\*The precise limits of “C Pile” material stockpiles C-1 and O-1 may be adjusted by EPA in the field as the removal progresses.**
